Manhole Inspection Summary

Manhole # S25UU1007MH

Insp Date: **5/3/07 4:41 PM**

Location Address: **403 CLUB RD**

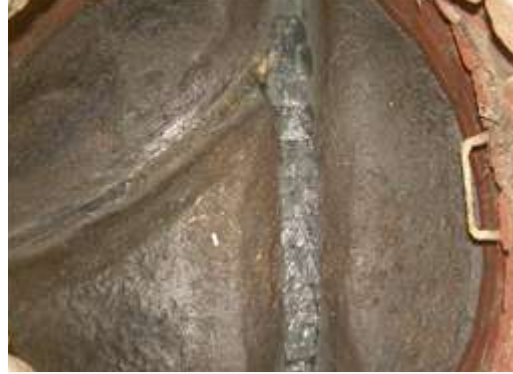
Top View

Corroded step.

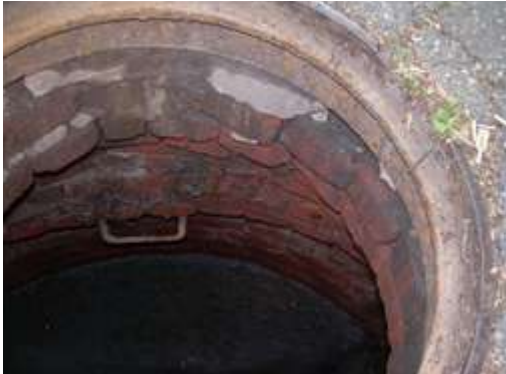
Defect

☒ **Leaks**

Condition: ☐ Sound ☐ Cracked ☐ Root Intrusion ☐ Loose Brick ☒ **Deteriorated**

Infiltration: ☐ None ☒ **Joint** ☐ Cracks ☐ Mortar ☐ Roots ☒ **Wall**

Condition: ☐ Sound ☐ Cracked ☒ **Root Intrusion** ☐ Loose Brick ☐ Deteriorated

Infiltration: ☐ None ☐ Joint ☐ Cracks ☒ **Mortar** ☒ **Roots** ☒ **Wall**

Infiltration: ☐ None ☐ Joint ☐ Cracks ☒ **Mortar** ☐ Roots ☒ **Wall**

Frame leaks. Adjustment deterioration and infiltration. Corbel root intrusion and infiltration. Barrel infiltration.

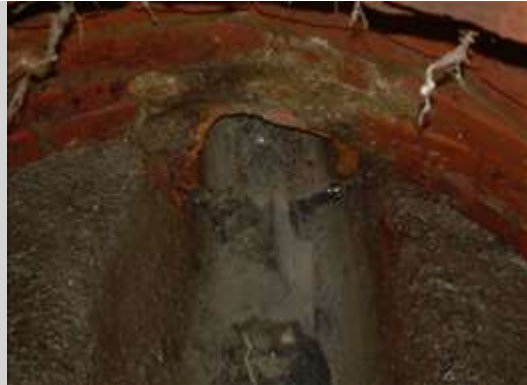
6 in. Circular Gravity Sewer Pipe Out @ 12 O'Clock

Infiltration: **Evidence** Pipe Seal Cond: **Unknown**

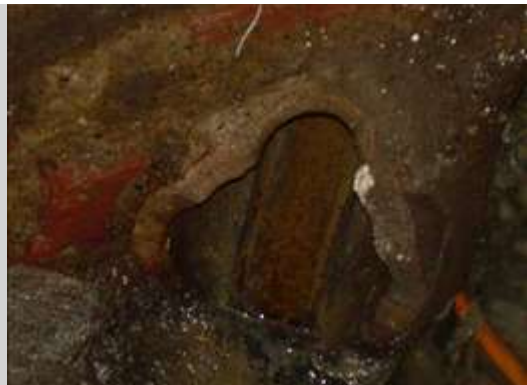
4 in. Circular Gravity Sewer Pipe In @ 5 O'Clock

Infiltration: **Evidence** Pipe Seal Cond: **Unknown**

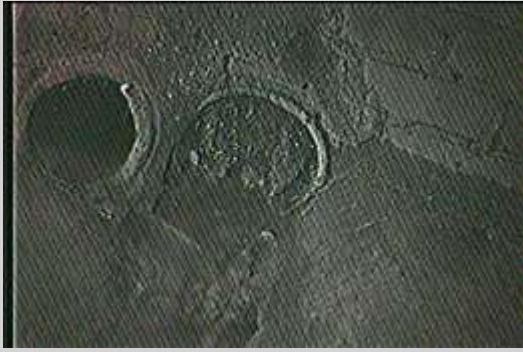
6 in. Circular Gravity Sewer

Deposits: ☐ None ☒ **Mud** ☐ Sludge ☒ **Debris** ☐ Grease

Silt Depth: **4** (in.) Deposits Extent: **Heavy**

Infiltration: **Evidence** Pipe Seal Cond: **Cracked**

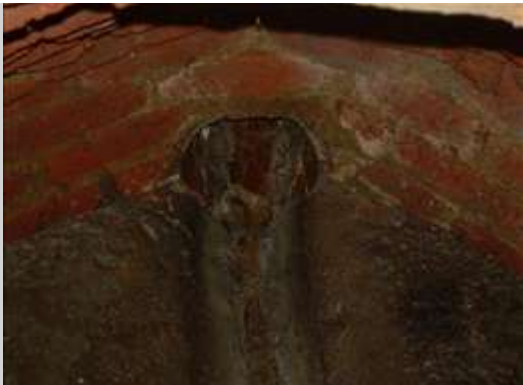
6 in. Circular Gravity Sewer

Deposits: ☐ None ☒ **Mud** ☐ Sludge ☐ Debris ☒ **Grease**

Silt Depth: **0** (in.) Deposits Extent: **Light**

Infiltration: **Evidence** Pipe Seal Cond: **Unknown**
